Heating/Piping/Air Conditioning

August 1974

Electrostatic descaler testing: an evaluation

No benefits can be attributed to electrostatic descaler after six months' service in domestic hot and cold water piping.

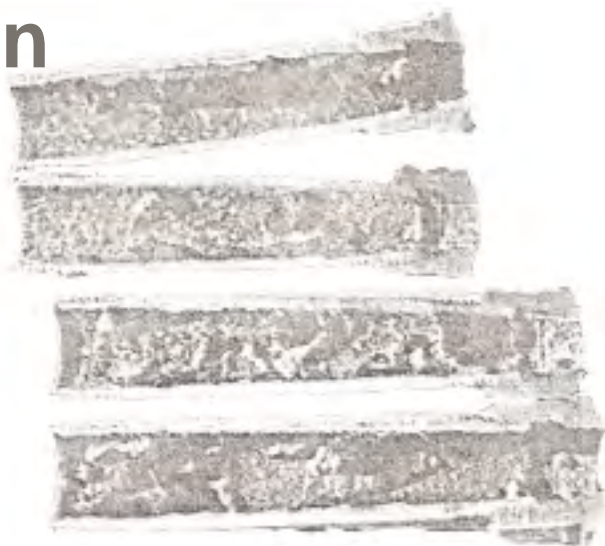
1. Specimens removed from piping to and from domestic hot water heater prior to installation of descaler.

Fig. 1 shows representative sections removed from the inlet and outlet piping connected to the old hot water heater. The degree of scaling and/or corrosion is readily apparent. These sections, together with a water sample drawn on 6/15/72, were forwarded to Truesdail Laboratories for testing and analysis at that time.

The samples that had been taken in June (Fig. 1) were very badly corroded and scaled, and both appeared to be in essentially the same condition. No true evaluation could be made of them.

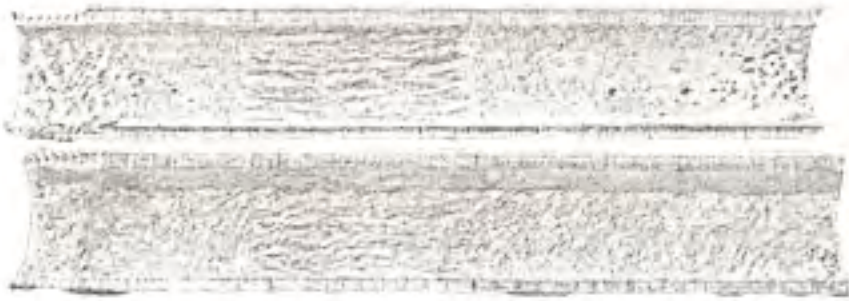
2. Specimen removed from new pipping to descaler after six months service (49.0 mg scale per sq. in.)

- One section of *new* ¾ in. pipe from the descaler feed line, shown in Fig. 2.

The specimens in Figs. 2 and 3 were taken from new piping installed to and from the descaler. These representative samples were used to estimate the scale deposition during our initial six month test period. The scale was mechanically removed from each pipe and weighed, with these results:

- Piping to descaler, 49.0 mg of scale per sq in. of pipe surface.

These results show a slightly lower value for scale density on the outlet section as compared with the inlet section. The difference is not believed to be significant in view of the fact that scale deposition would be expected to decrease with increasing distance from the feed source because of depletion of scale-forming minerals.

From the overall examination of the pipe sections and in particular from evaluation of the specimens in Figs. 2 and 3, we concluded that the test descaler was not effective in preventing scale deposition, and we were unable to detect any measurable reduction in corrosion potentials.

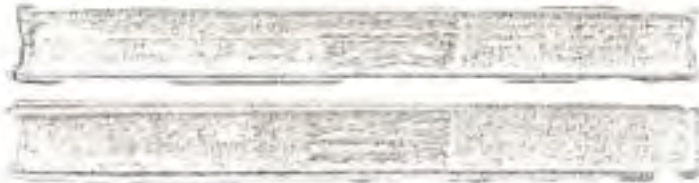
3. Specimen removed from new pipping to descaler after six months service (45.4 mg scale per sq. in.)

- One section of *new* ¾ in. pipe from the descaler outlet line, shown in Fig. 3.

- Piping from descaler, 45.4 mg of scale per sq in. of pipe surface.

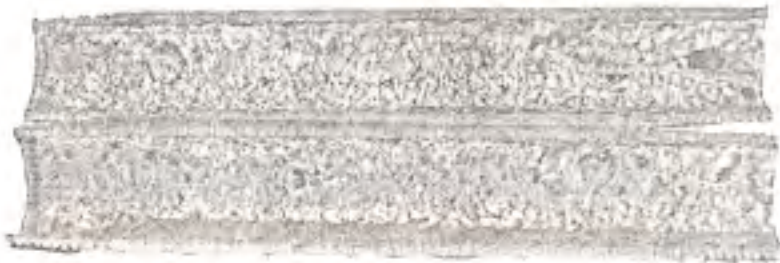
4. Specimen removed from old pipping to new water heater six months after installation of electrostatic descaler..

- One section of *old* ¾ in. pipe from the domestic hot water heater feed line, shown in Fig. 4.

The specimens in Figs. 4 and 5 were too heavily corroded and scaled to permit an evaluation of differences in scale density. In general, they appeared to be fairly heavily scaled, again indicating a lack of effectiveness of the descaler.

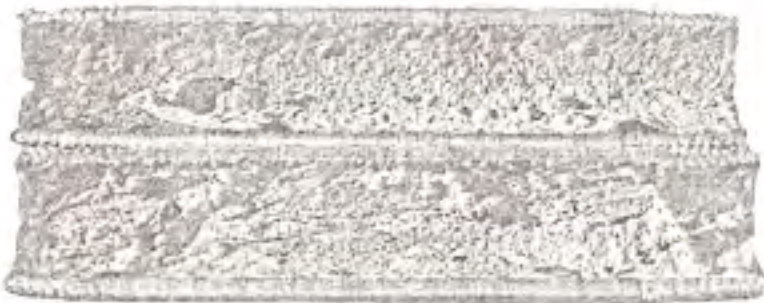
5. Specimen removed from old pipping from new water heater six months after installation of electrostatic descaler..

- One section of *old* ¾ in. pipe from the domestic hot water heater outlet line, shown in Fig. 5.

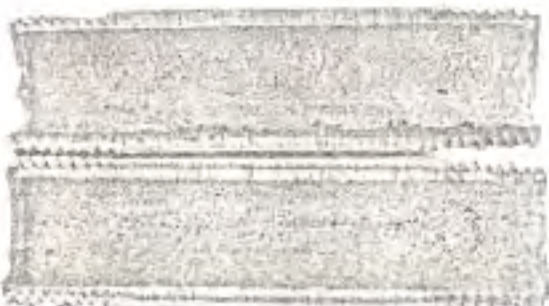
6. Specimen removed from new riser for outermost lawn sprinkler six months after installation of descaler.

- One section of *new* ½ in. pipe from the outermost lawn sprinkler riser, shown in Fig. 6.

The specimen in Fig. 6, a new riser pipe from the sprinkler system, showed a minimal amount of scale. Since it was used only intermittently and was distant from the water source, it would be expected to show light scaling. It was not considered significant in evaluating the descaler.

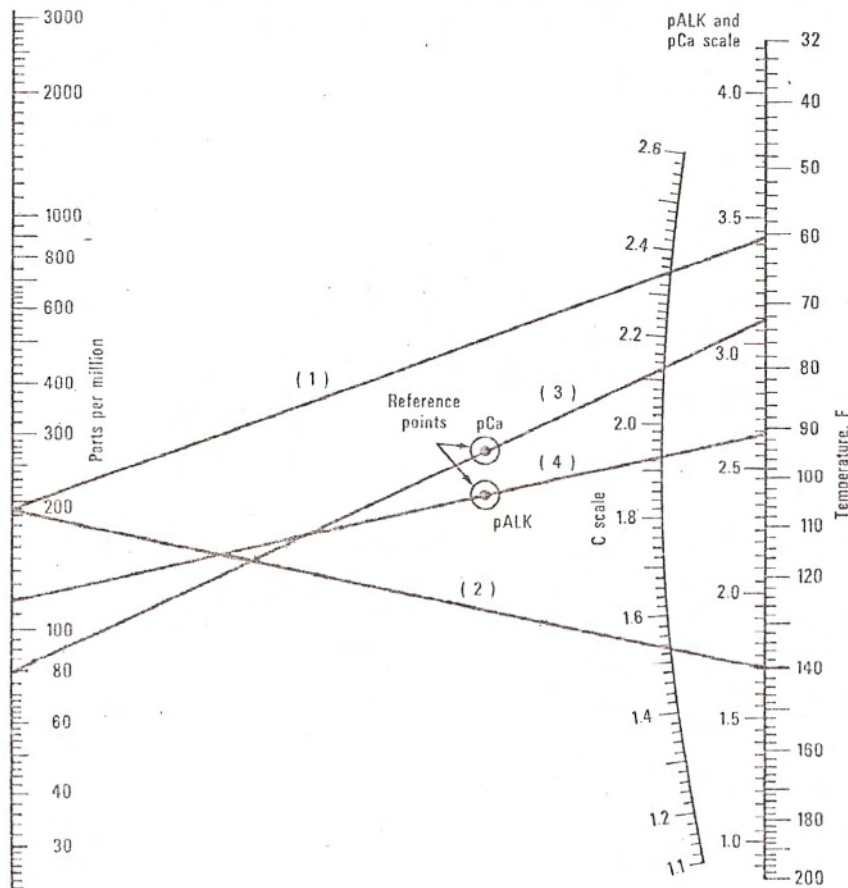
Fig. 7 offers a quick means of determining the saturation index.

7 Nomograph for Langelier Index. For water analyzed in Table 1, pH₆₀ at 60 F = 2.35 + 3.09 + 2.62 = 8.06 and pH₁₄₀ at 140 F = 1.54 + 2.62 + 3.09 = 7.25. Index at 60 F = 8.36 - 8.06 = +0.30; Index at 140 F = 8.36 - 7.25 = +1.11. (Nomograph reprinted by permission from Reference 9.)

If we consider water whose composition is shown in Table 1 at both 60 F (normal cold water) and 140 F (normal hot water), then referring to Fig. 7, we find that the saturation index varies from +0.30 at 60 F (normal cold water temperature) to +1.11 at 140 F (normal hot water temperature). In other words, our water source possesses a moderate scale-forming tendency at the cold water temperature and a noticeably more aggressive character at the elevated domestic hot water temperature. Therefore, valid conclusions could be drawn from our test.
