# Test of a Magnetic Device for the Amelioration of Scale Formation at Treatment Facility D

December 1996

## **Test of a Magnetic Device for the Amelioration of Scale Formation at Treatment Facility D**

Environmental Protection Department  
Lawrence Livermore National Laboratory  
University of California  
Livermore, California 94551

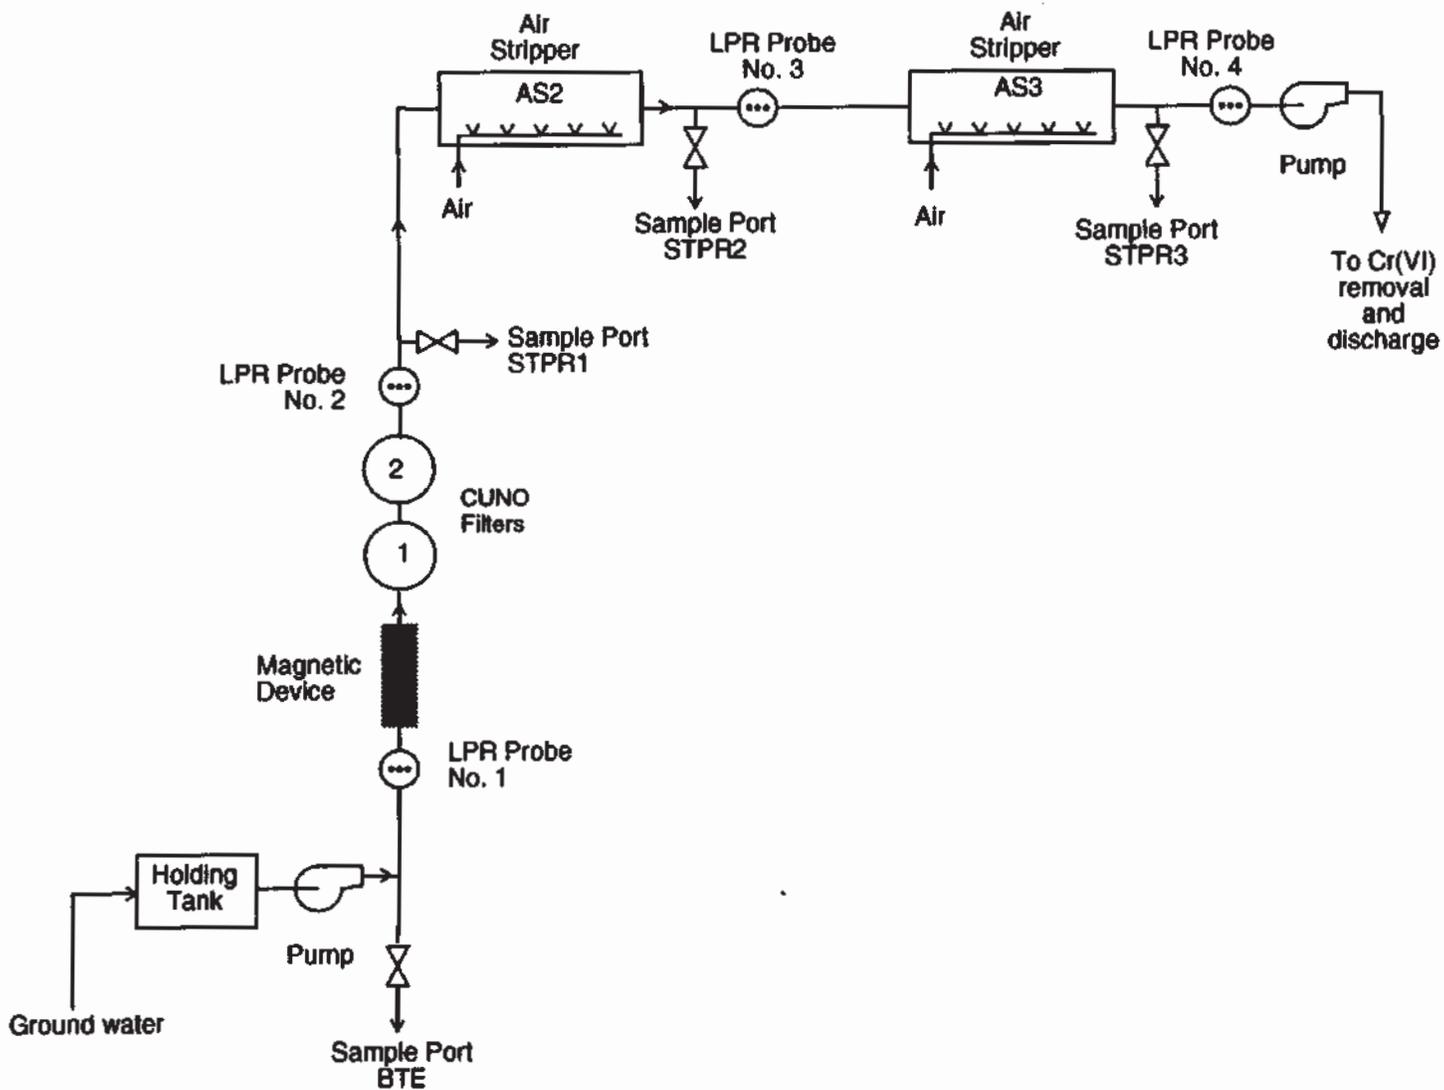
Figure 1 is a schematic diagram of the overall system at Treatment Facility D (see the *Operations and Maintenance Manual, Groundwater Treatment Facility "D", Building 472 and Adjacent Equipment*, Rev. 0, Lawrence Livermore National Laboratory, November, 1995, for additional details and the operating characteristics of this facility). In this facility, water from several wells is pumped into a holding tank, and then into the treatment process. The treatment process is operated for about 8 h during the daytime, and then shut down overnight while the holding tank is again filled. The scaling tests reported here were conducted while the facility was operated in this manner, i. e., with alternating periods of flow and no-flow with the specimens and coupons remaining in place throughout the test. The LPR and water chemistry measurements were carried out during water flow, near the end of each day's treatment run.

Figure 1. Simplified schematic diagram of flow system at Treatment Facility D.

As shown in Figure 1, for Test No. LX-122, the magnetic unit (Descal-A-Matic® Model DC-36) was installed in the main water-supply line, after the source of the water from the holding tank and before the two stages of air stripping. This unit was rated for a flow rate of 36 gpm; in all of the tests, the water flow rate was maintained at  $32.5 \pm 0.2$  gpm.

Table 4. Changes in weight of the electrodes on the LPR probes. (See Figure 1 for probe position and Table 3 for test duration.)

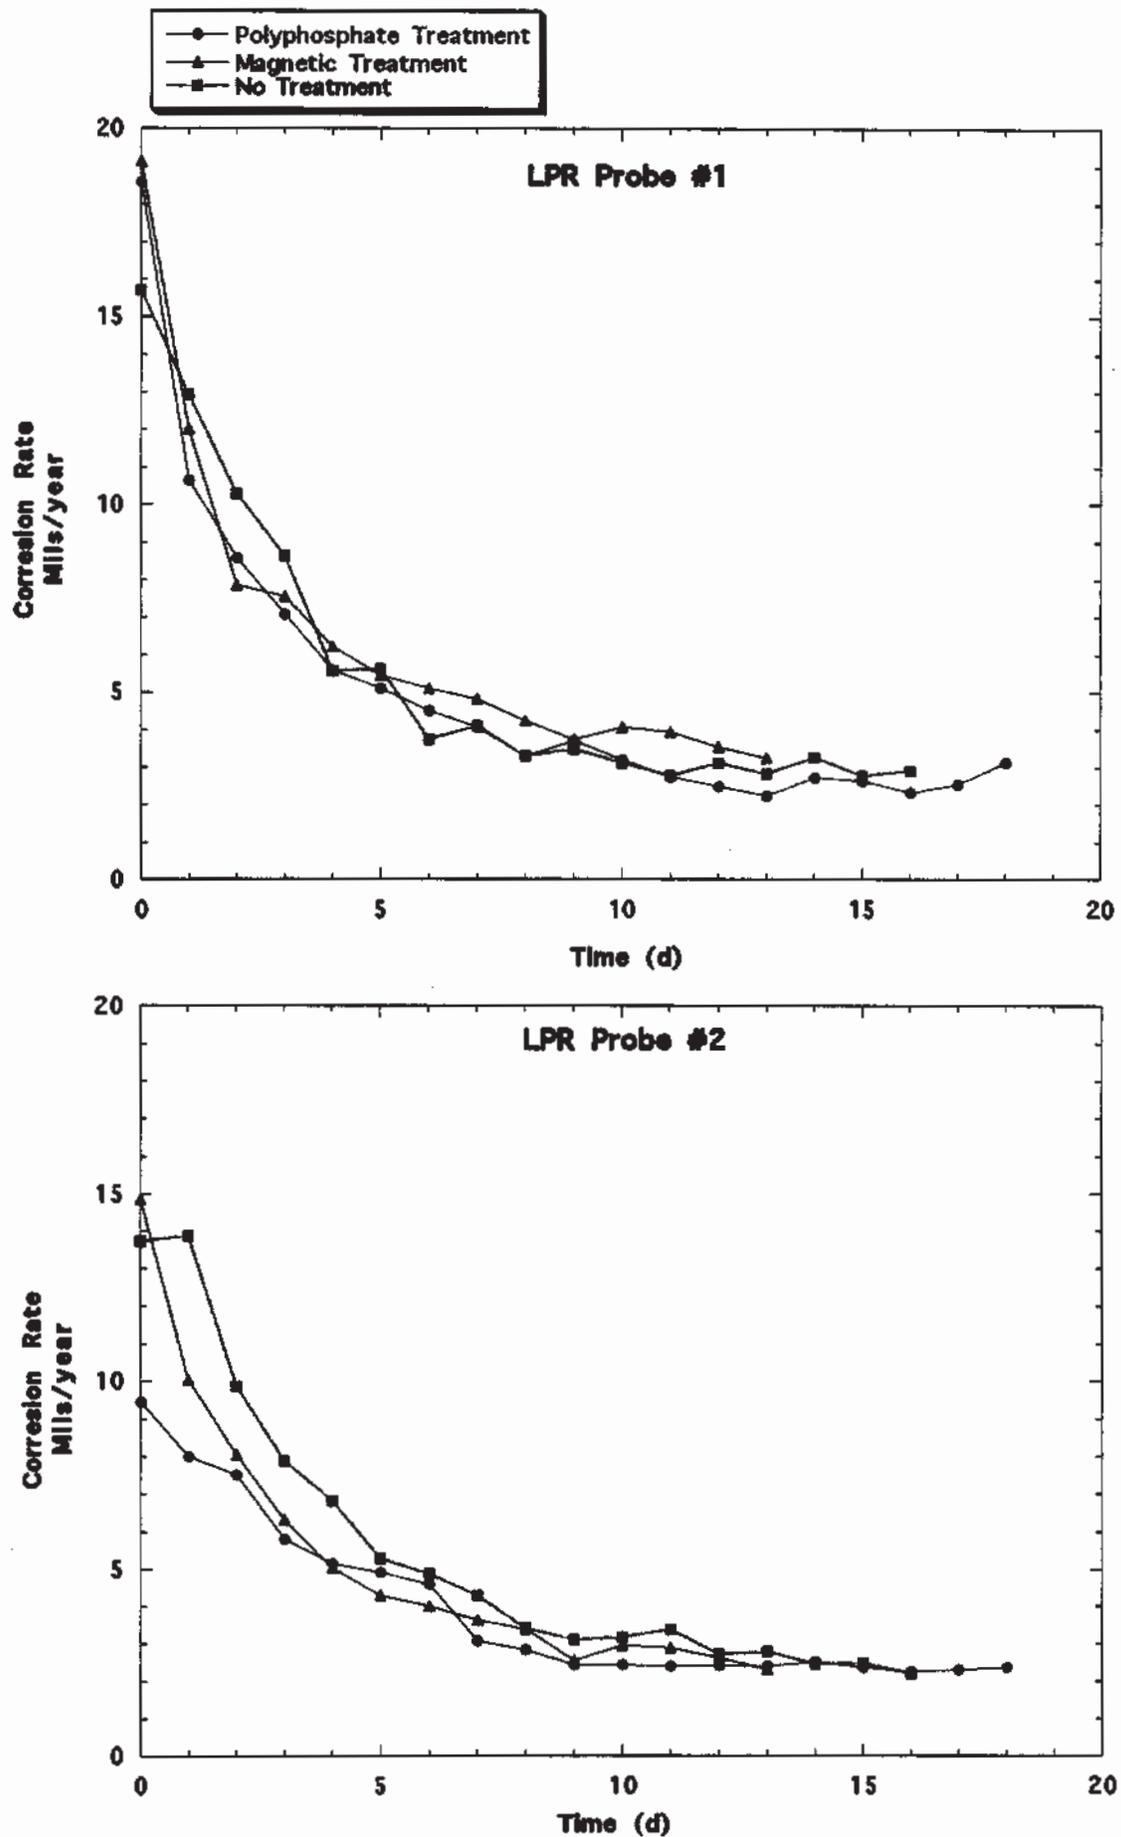
In the present experiments, the LPR measurements at each probe were performed at the end of each day's facility operation. Figures 2 and 3 are plots of the data obtained. Measurement of the calibrating resistor during each day's series showed that the standard deviation of the measurement at 10 mpy was ~0.3 mpy.

Figure 2. Linear polarization resistance measurements at Probe numbers 1 and 2.

Several significant features can be seen in the LPR data. First of all, as can be seen in the data for the test without water treatment (Figs. 2 and 3), the apparent "equilibrium" corrosion rate of the electrodes was progressively lower in going from Probe 1 to Probe 4. This is expected even in a non-scaling environment, because, as the pH of the water increases as it passes through the facility, the actual corrosion rate of the steel should trend to lower values. The additional effect of the deposition of the  $\text{CaCO}_3$  scale, if it is evident, would be superimposed on the effect of corrosion.

As can be seen in Figure 2, which depicts the LPR data for the water prior to the air stripping, there is very little effect, if any, of the type of water treatment on the LPR results. The effects of the water treatment on the apparent corrosion rates are more clearly differentiated after the water has undergone air stripping, especially in the data for LPR Probe No. 3, which was located between the two stages of air stripping. As can be seen in Fig. 3 (top curves), after a few days, the indicated corrosion rates were generally the highest for the JP-7 treated water, presumably because there is less  $\text{CaCO}_3$  scaling under this condition. For the untreated water, and at intermediate times, the apparent corrosion rates were lower for the untreated water, probably because of the

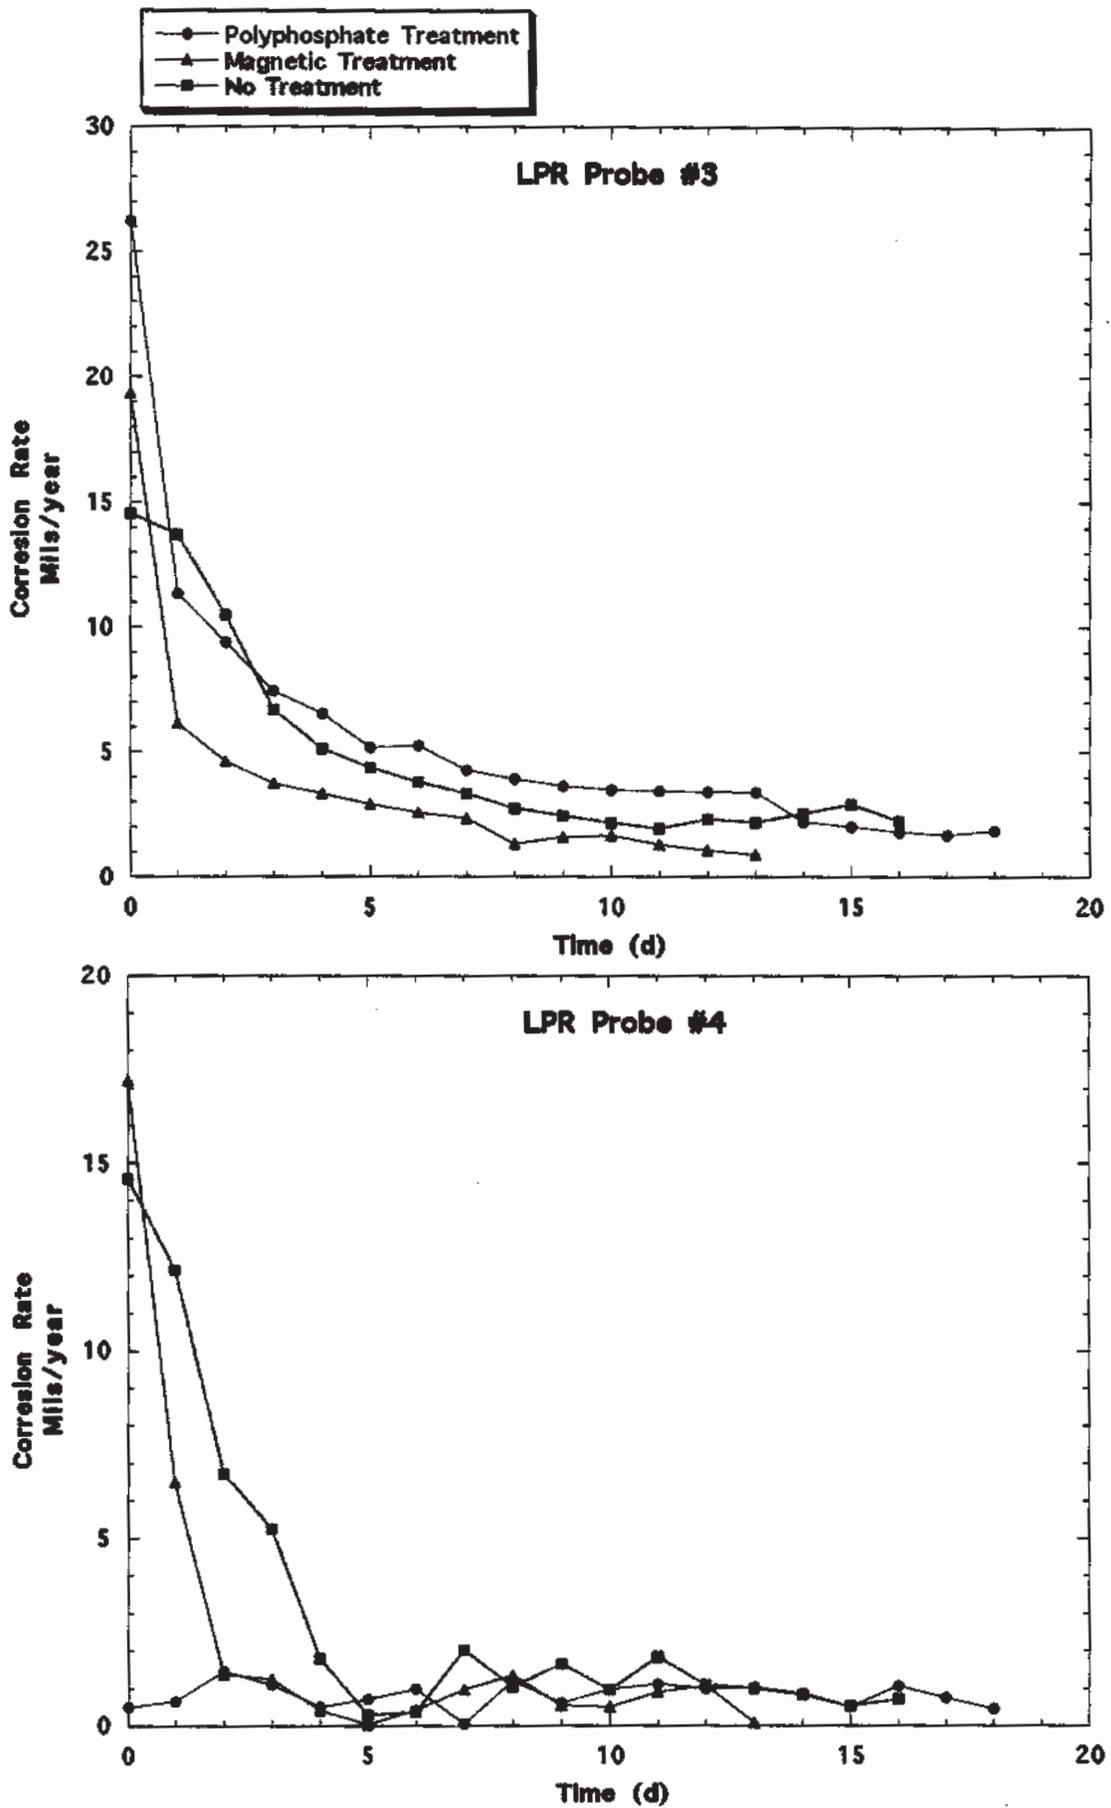
Figure 3. Linear polarization resistance measurements at Probe numbers 3 and 4.

faster build-up of the  $\text{CaCO}_3$  scale. If the magnetic treatment (or any anti-scale treatment) were effective in retarding scale formation, the apparent LPR corrosion rate should always be higher than that observed in the absence of treatment. The contrary effect was observed: the corrosion rates indicated by Probe No. 3 were lower when the magnetic device was in place. This observation of even more scaling with the magnetic treatment is in agreement with the coupon results.

The reason for the initially low LPR values for Probe No. 4 in the polyphosphate treated water (Fig. 3, bottom curves) is unknown. However, there was an indication that the orientation of Probe No. 4 in the flow stream was not completely satisfactory. It was observed that the deposition of scale was uneven on the electrodes of Probe No. 4.

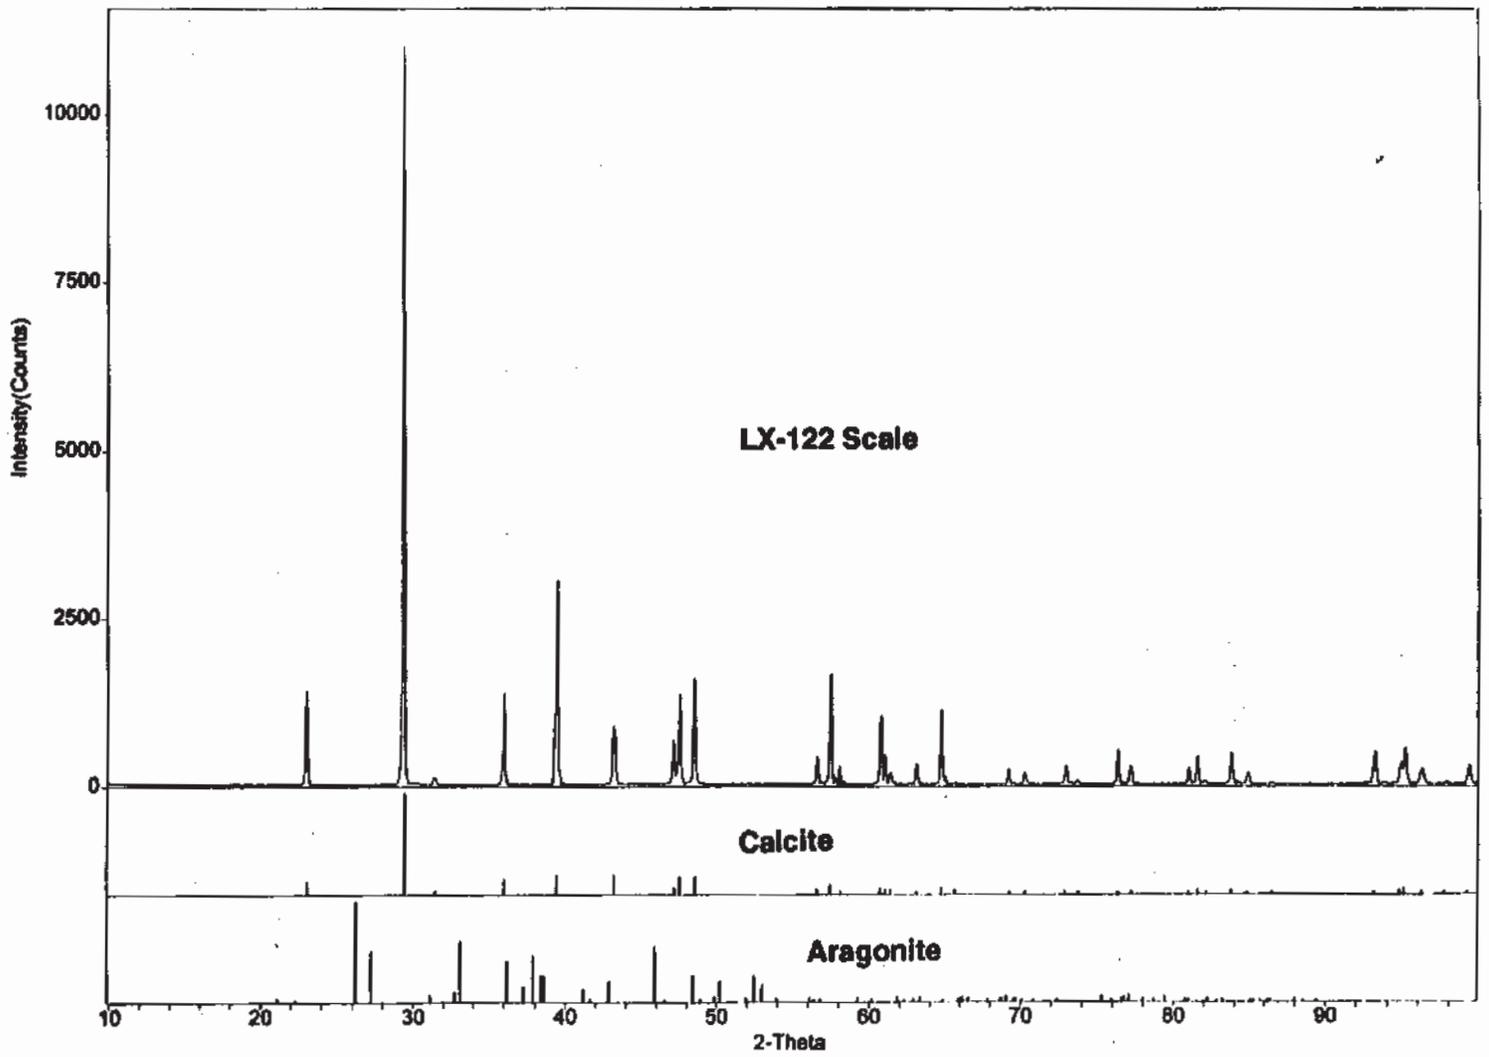
After Tests LX-116 and LX-122, powdered samples were scraped off the polyacrylate windows in air-stripper tank No. 2, and analyzed by x-ray diffraction. Figure 4 shows the diffraction pattern for the scale formed during Test LX-122, when the magnetic device was in place, together with the reference patterns for calcite and aragonite. Figure 5 compares patterns for samples from both LX-122 and the baseline Test LX-116. In both of the samples, the major component of the scale is clearly calcite, with no evidence of aragonite (or valerite, another possible crystal form). It can be seen in Figure 5 that there are some differences in the two patterns (i. e., the number of diffraction lines and the line intensities), but these differences are not significant in the identification.

Figure 4. Diffraction pattern of scale formed during Test LX-122 with the magnetic unit, together with reference patterns for calcite and aragonite.

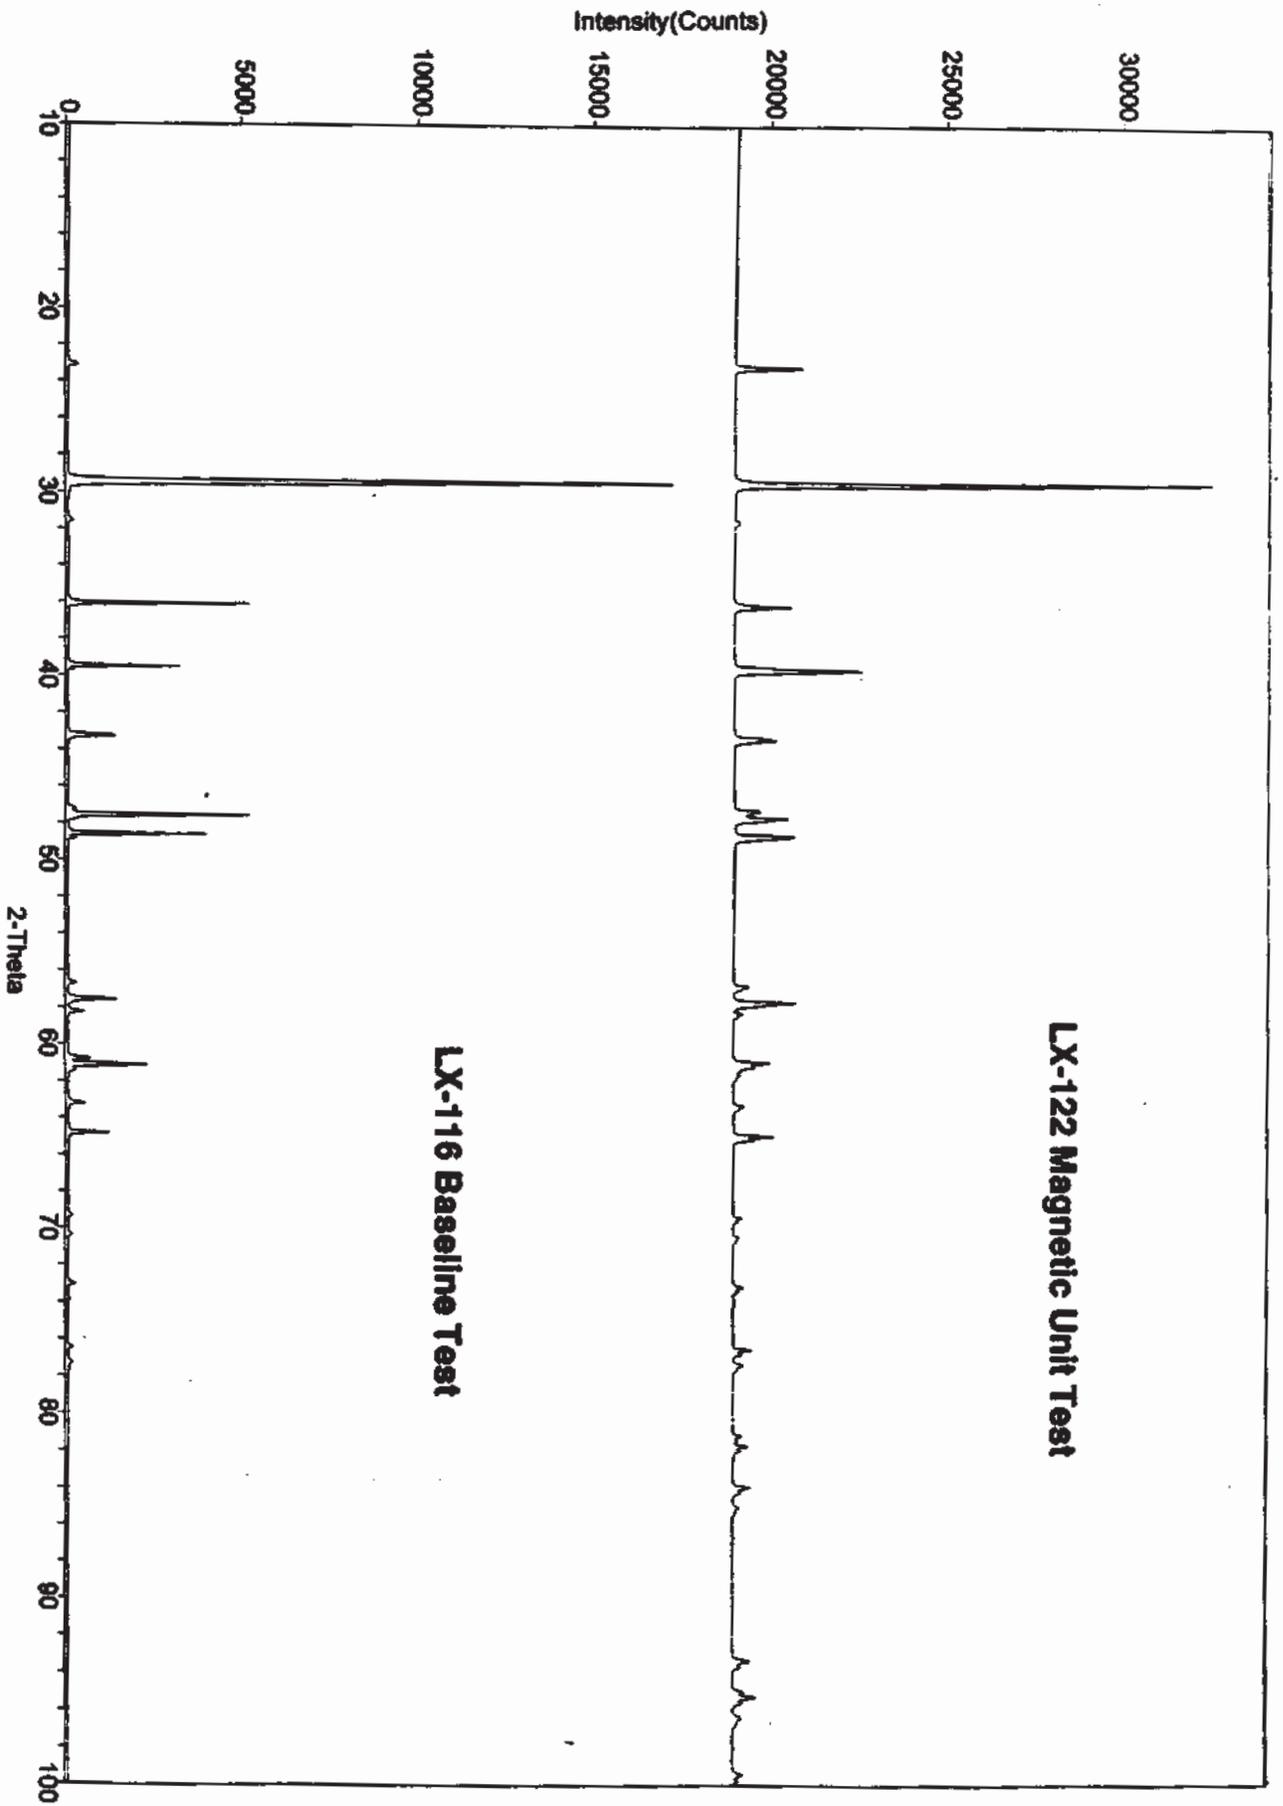
Figure 5. Diffraction patterns of scale formed during the baseline test LX-116, and the magnetic unit test, LX-122.

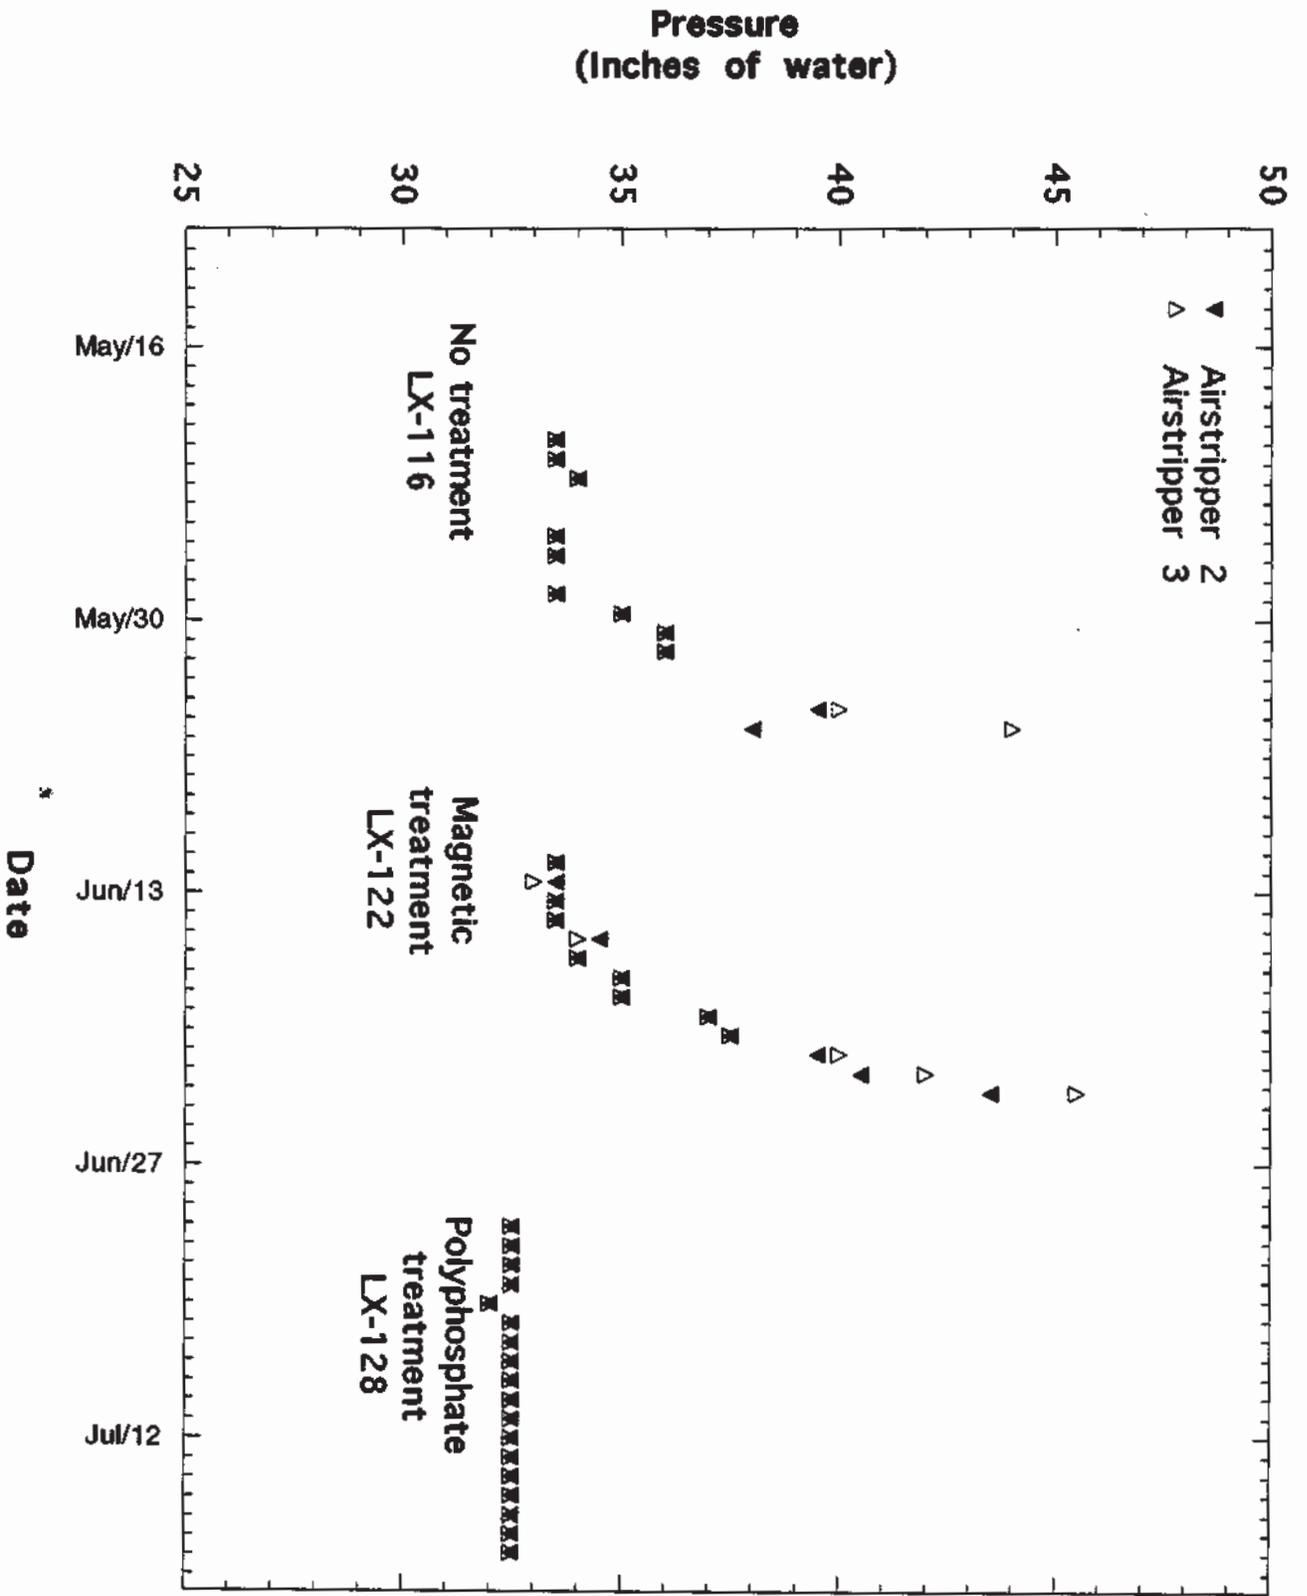
Figure 6 illustrates the variation of the air-stripper diffuser back pressures during the tests. With the addition of JP-7 to the water (in Test LX-128), there was essentially no change in the back pressure during this test. With no anti-scale water treatment (Test LX-116), the pressure started to increase after about 8-day's running. In the case of Test LX-122, with the magnetic device in place, the pressure began to increase after only 4 days, and the test was terminated after 13 days because the pressure had reached an intolerable level.

Figure 6. Back pressure at the air diffusers.

An operational characteristic of the treatment facility equipment that became a good indicator of the extent of scaling was the back pressure on the diffusers in the air stripper tanks. These diffusers consist of sections of pipe that are drilled with multiple

small holes, through which the air flows into the water as the water is pumped through the tanks. The formation of scale in and around these holes restricts the openings and creates increasing back pressures that were indicated on gauges and recorded during the treatment tests.
